NASA
Technical Memorandum 106621

Heat Treatment Effects on the Tensile Properties and Microstructures of a SiC/RBSN Composite in Nitrogen

Prepared for the
Eighth Conference on Advanced Structural Fiber Composites
sponsored by International Conferences on Modern Materials & Technologies
Florence, Italy, July 1-4, 1994

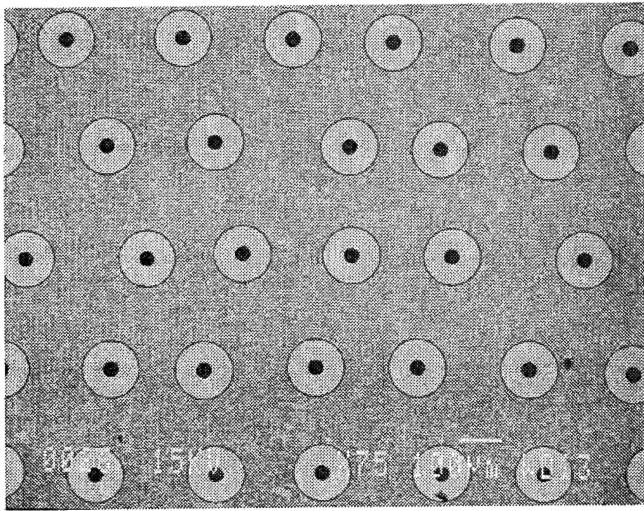
Figure 1.—Cross-section showing microstructure of unidirectional SiC/RBSN composite ($V_f = 24\%$).

A polished cross-section of a typical 24 vol% SiC/RBSN composite specimen is shown in figure 1. The fibers are uniformly distributed in the non-uniform pore size matrix.

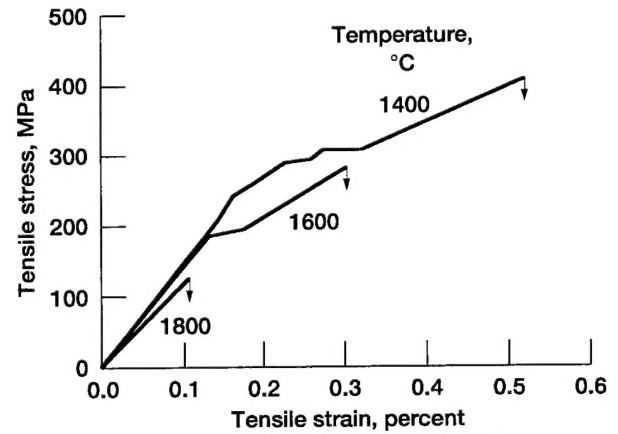
Figure 2.—Room-temperature tensile stress-strain curves of SiC/RBSN composites ($V_f = 24\%$) after 1 hr heat treatment in nitrogen.

The room-temperature tensile stress-strain curves for the 1-D SiC/RBSN composites after 1 hr heat treatment in nitrogen at 1400, 1600, and 1800 $^{\circ}\text{C}$ are shown in figure 2. Since the stress-strain curves of the as-fabricated composite and the composite heat treated in nitrogen for 1 hr at 1400 $^{\circ}\text{C}$ are similar, the stress-strain curve of the as-fabricated composites is not shown in figure 2. The 1400 and 1600 $^{\circ}\text{C}$ curves show three regions: an initial linear elastic region, a non-linear region, and a second linear region. The existence of a non-linear region in the stress-strain curve indicates bridging of matrix cracks by the fibers, and tough composite behavior. The stress-strain curve of the 1800 $^{\circ}\text{C}$ heat treated composite displays an initial linear region and no strain capability beyond matrix fracture. The slope of this line is slightly lower than that of the other two.

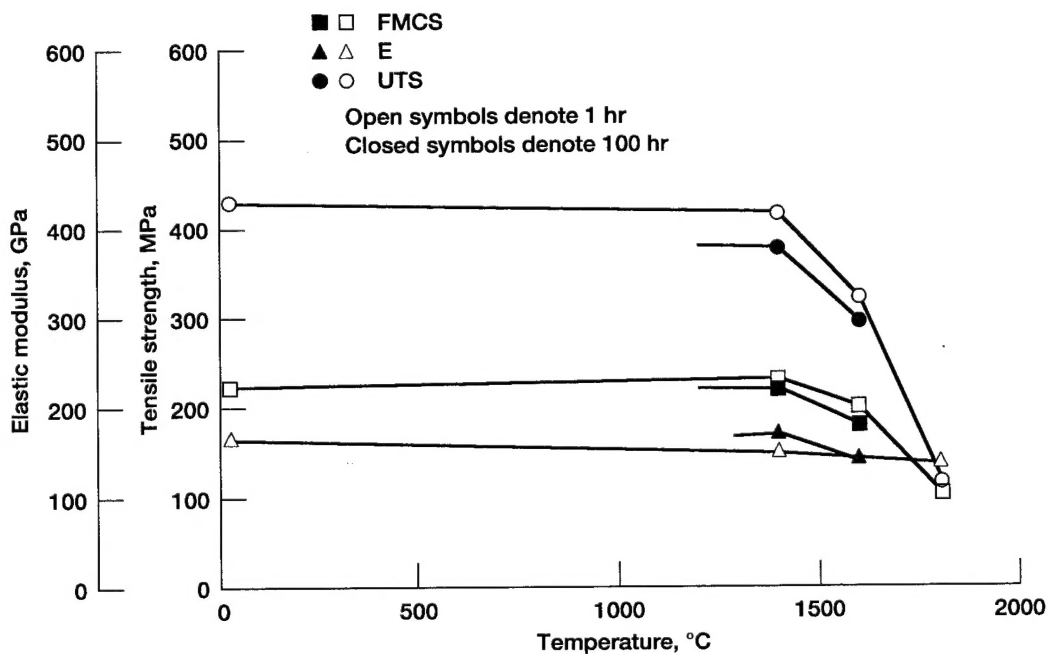
Figure 3.—Effects of heat treatment temperature and time on tensile properties of SiC/RBSN composites.

The effect of 1 and 100 hr heat treatment in nitrogen on primary elastic modulus (E), first matrix cracking stress (FMCS), ultimate tensile strength (UTS) of the composites are illustrated in figure 3. Each data point represents an average of three tests. Since the specimens heat treated at 1800 $^{\circ}\text{C}$ for 100 hr were very weak, their tensile data could not be plotted in figure 3. As seen in the figure, for up to 100 hr of exposure at 1400 $^{\circ}\text{C}$, the composites retained as-fabricated mechanical properties. With increasing temperature of exposure the elastic modulus, the first matrix cracking strength, and the ultimate tensile strength decreased, but the ultimate tensile strength showed greater loss with exposure temperature than did the matrix fracture strength or the elastic modulus.

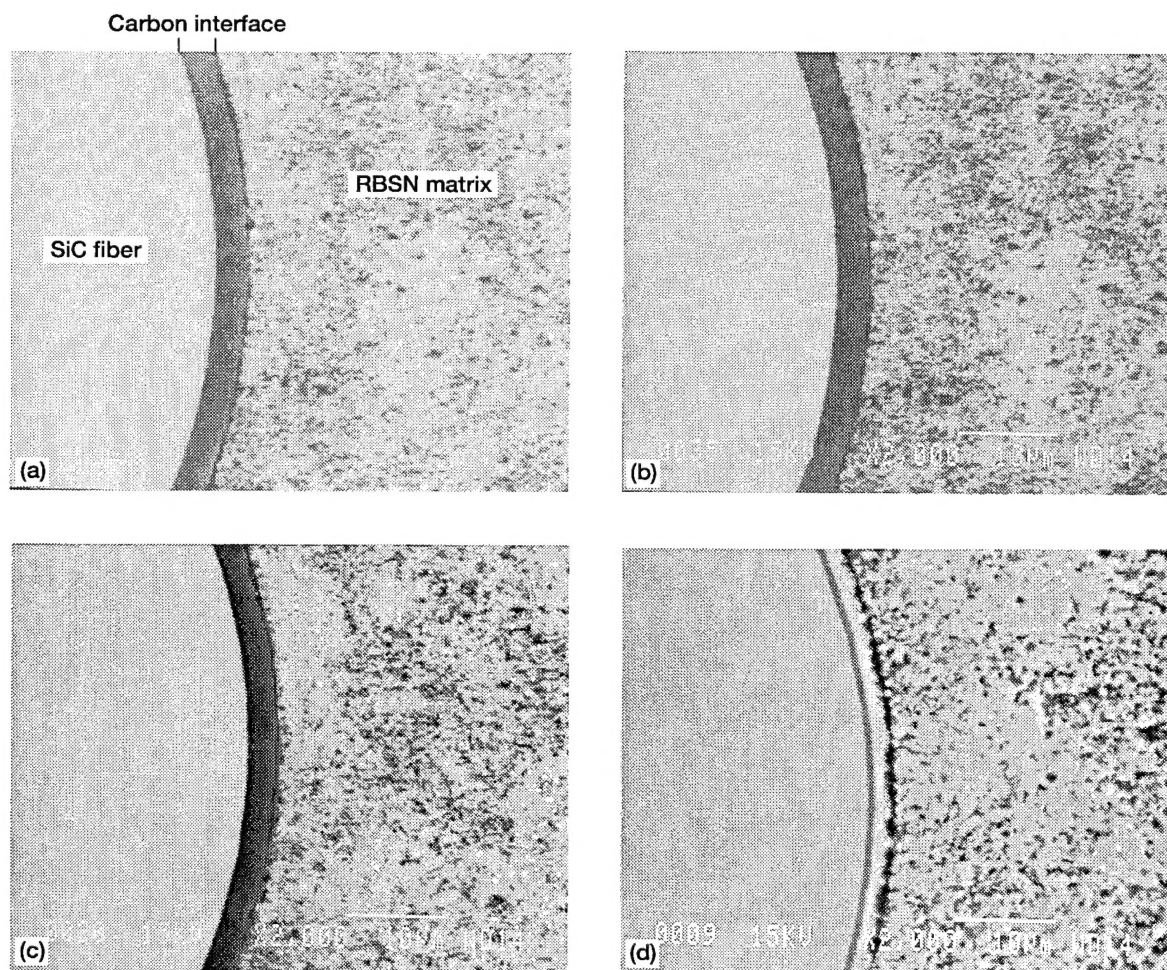
Figure 4.—Influence of one-hr heat treatment in nitrogen on microstructure of SiC/RBSN composite. (a) As-fabricated. (b) 1400 °C. (c) 1600 °C. (d) 1800 °C.

Examination of the cross-sections of the heat treated composites indicates that up to 1600 °C, the RBSN matrix and carbon-rich interface coating remained stable (fig. 4(c)). Beyond this temperature, the carbon-rich interface coating reacted with the RBSN matrix (fig. 4(d)). As a consequence, the thickness of the carbon coating is ~ half that of the as-fabricated composite. In addition, the size of the matrix pores has increased. Limited x-ray measurements performed on composites heat treated at 1800 °C showed increasing amounts of silicon in the RBSN matrix with increasing exposure time. Increasing amounts of silicon in the RBSN matrix indicates dissociation of silicon nitride to silicon and nitrogen. In fact, it is known that silicon nitride dissociates at ~ 1800 °C in 0.1 MPa nitrogen (ref. 11). Composites heat treated for 1 hr at and beyond 1600 °C also showed fiber degradation. A diffusion zone started emanating from the outer surface of the SiC fiber adjacent to the carbon-rich surface coating. The thickness of this zone increased with increasing temperature of exposure or with increasing time of exposure at a given temperature. A photomicrograph of the cross section of the composite heat treated at 1800 °C for 1 hr showing the growth of the zone is shown in figure 5. The growth of the diffusion zone at the interface of the carbon coating and the SiC sheath is similar to that observed in the individual SiC fibers heat treated beyond 1500 °C for 1 hr in an argon environment (ref. 12), but the thickness of the zone in the composite is smaller than that in the individual fibers. It has been shown by TEM analysis of heat treated SiC fibers that the diffusion zone consists of equiaxed recrystallized SiC grains (ref. 12). This study showed that strength degradation in this fiber is due to recrystallization and growth of SiC grains and that a relationship exists between the strength of the heat treated fibers and the thickness of the recrystallization zone.
